Special Volume on  
**Conservation of  
Stone Objects**

# Conservation of Stone Objects

New Series - General Section - Chemical Conservation,  
Vol 10, 2003

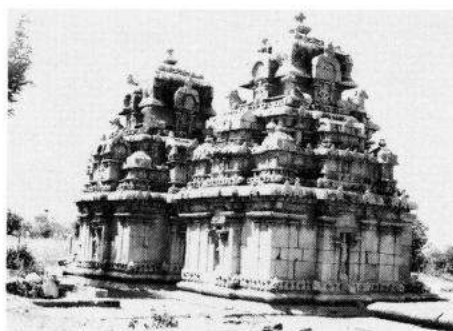
*Muvarkoil at Kodumbalur*

The *Muvarkoil* at *Kodumbalur* is well preserved structurally. But the granite is flaking in layers like plates in many places. The same is the case in some sculptures where the layers in the granite have fallen in patches. For example the *Ardhanarisvara* in the eastern wall of the central shrine, *Gangadara* in the east, and *Vinadara Dakshinamurti* on the south, in the southern shrine are a few to cite. These beautiful sculptures are losing their fine carving due to flaking. The flaking may be due to the action of

water on the weak chemicals there in as described *supra* and weakening the bond of successive layers. Detailed study is necessary to prevent further flaking and peeling of the granite layers. It is surprising to see that the sculptures of *Siva* on

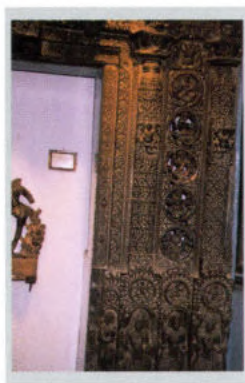
Missing Portion of the Hoysala Period Carved Stone Door and Cornices Restored Using Visually Similar Looking Wood

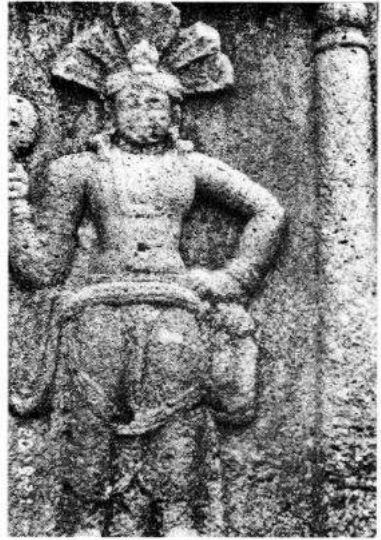
*Sculpture Affected by Erosion*

can the surface erosion of stone be stopped, or at least retarded. There are various types of coatings but as yet none of them is a perfect solution. Each one of them is having some deficiency or the other. In practical terms, it is not desirable to block the pores of a stone. Very often, it is more harmful than the erosion itself. We have yet to find a solution, which will consolidate the surface but will not stop the migration of water vapour from inside the stone, because otherwise it may cause eruption of the stone surface.

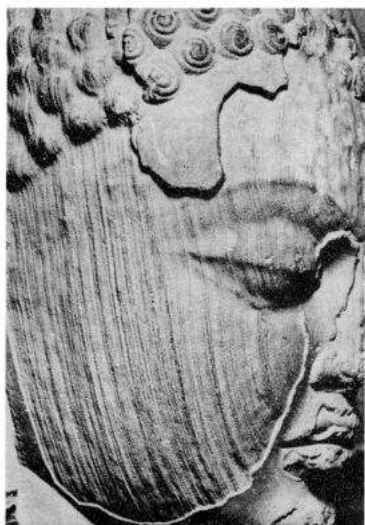
*Exfoliated Stone Surface*

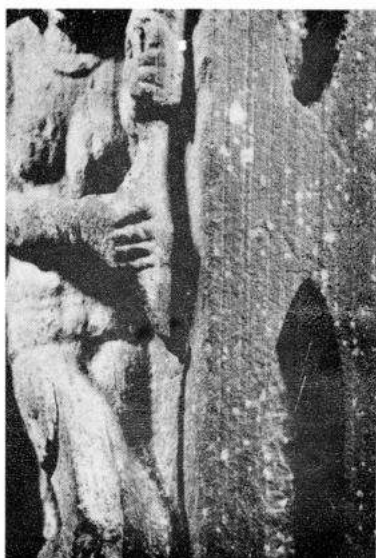
*Cracked Stone Sculpture*

of the loss of the strength of binding material between the layers. In order to rectify the situation one should introduce fresh binder between the layers. First of all we are not sure which binder would last for a long time. We know that organic binders have a limited life. Apart from that when we introduce a chemical or a solution it does not penetrate deep inside. As such the binder binds the edges of the layers while from inside there is a void. As a part of a research project, we tried several methods at Mathura but none of them is satisfactory. More

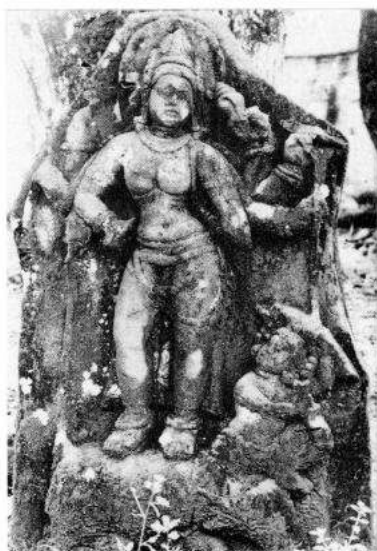
*Sculpture Affected by Micro-organisms*

In our country, with a tropical climate, having heavy rainfall and plenty of moisture, the growth and development of different types of microorganisms on stone is very natural. We can see presence of algae and moss over every type of building, including monuments and historical buildings. These microorganisms grow very quickly and cover the surface of the building. There are several

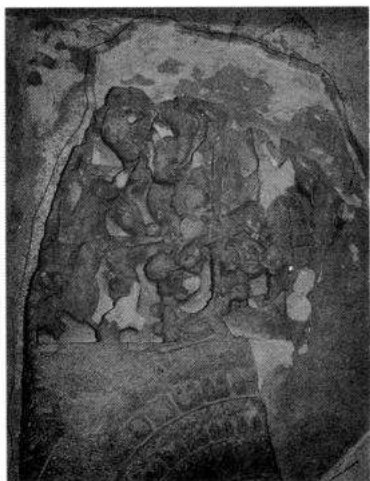
*Affected Limestone Sculpture*

The *Amaravati* sculptures are prone to salt action and deterioration by atmospheric pollutants. The moisture present in the air dissolves the acidic vapours and gasses and the acids thus formed adhere to the surface of the lime stone sculptures and make the sculptures to disintegrate. The surface of the limestone sculptures takes very easily the ugly looking oily accretions because of the human touch. The salt absorbed by the limestone sculptures is removed by poulticing using moist and neutral paper pulp applied to the surface of the sculpture. In the case of the affected loose sculptures, after all the salt present is removed by immersion in

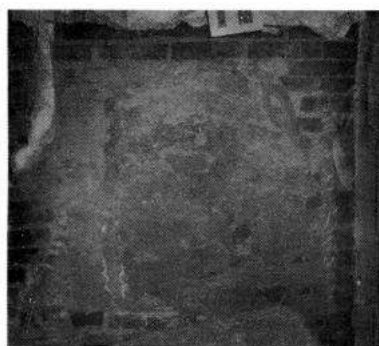
*View of the Scoured out Wall After the Removal of the Sculpture*

The limestone sculptures are found with dissolved salts as they are found embedded on to the walls. The ingress of water carrying dissolved salts are the main reason for the salt action, it has been decided to remove the salt by dissolution and or by poulticing with neutral paper pulp with distilled water. 134 sculptures have been identified to be removed from the wall. After their removal, the cavities in the walls will be filled with

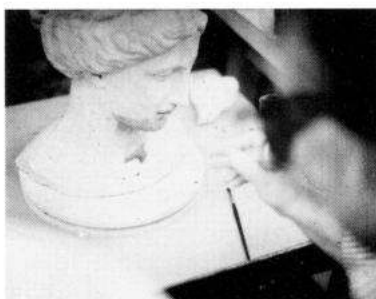
*Laser Cleaning of a Marble*

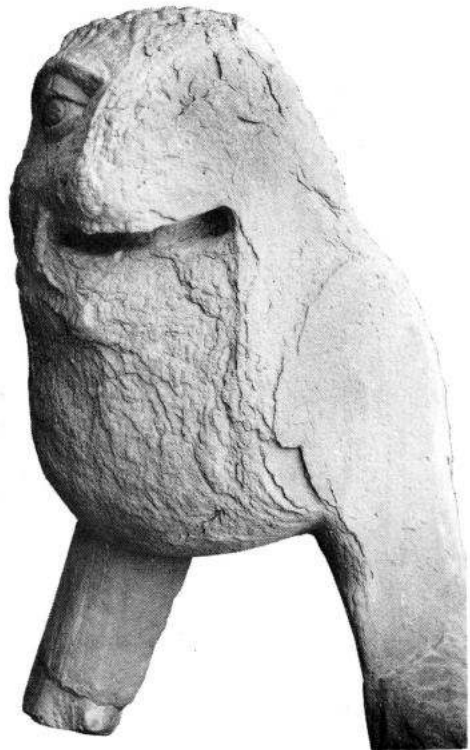
*Splitting of Layer is a Major Problem in Sandstone*

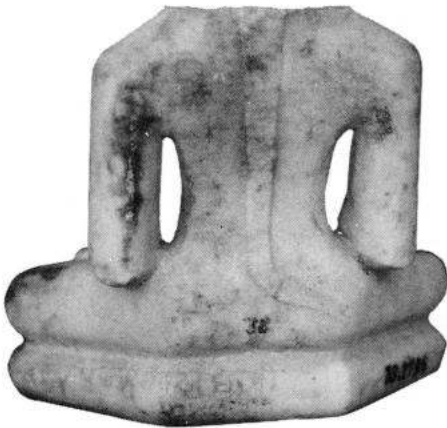
*Soiling Surface Can Spoil the Beautiful Surface of Marble*
